Condenser optic lifetime issues for laser and capillary discharge EUV sources

William P. Ballard, Philip Grunow,
Neal Fornaciari

Source Workshop

February 23, 2003

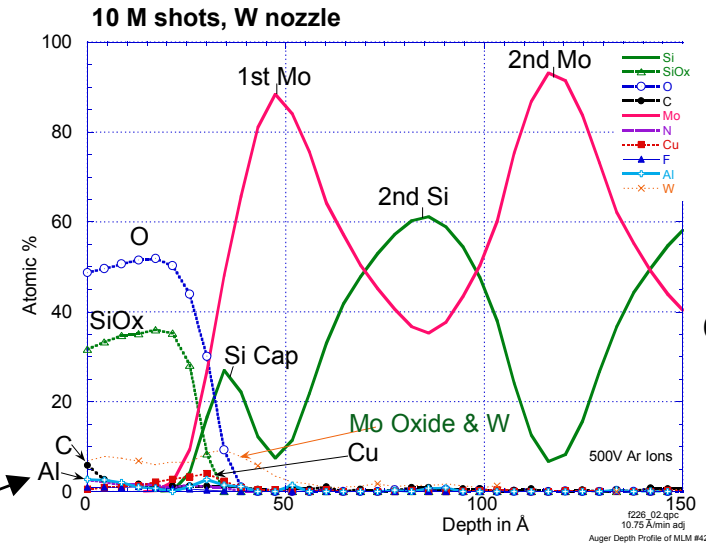
4 mm

More erosion

Erosion can be as high as ~40 Å/10M shots Gap, angle dependence needs further study

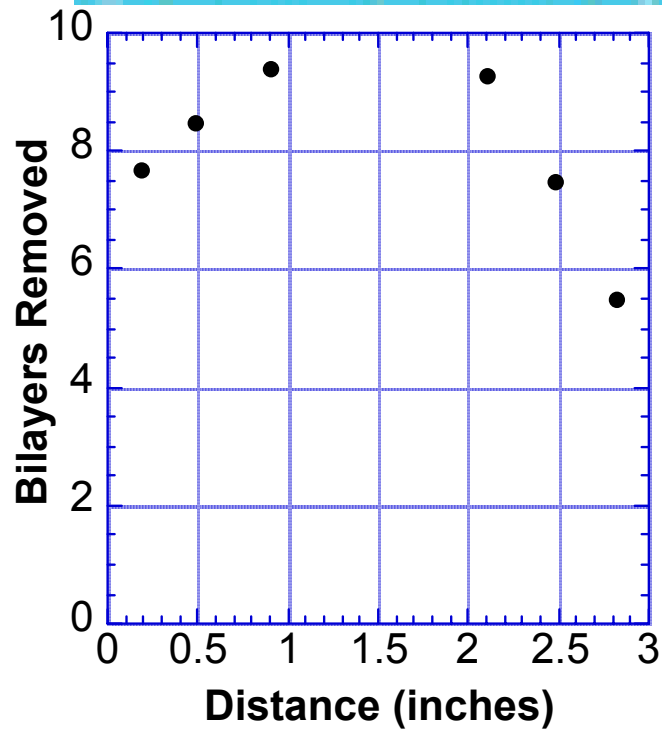
Plot of Bilayers Removed after Exposure to 230M Shots

Si Capped MLM Witness Samples Were Exposed to 230M Shots at the Condenser

- The inner and outer MLM witness samples had a total of 10 bilayers and were Si Capped
- Fixed parameters include:
 - 4mm nozzle separation,
 - 50 μ m nozzle orifice,
 - laser Chains 1 & 2 used
- A total of 7 Auger depth profiles were taken on the inner and outer C1 witness sample positions.

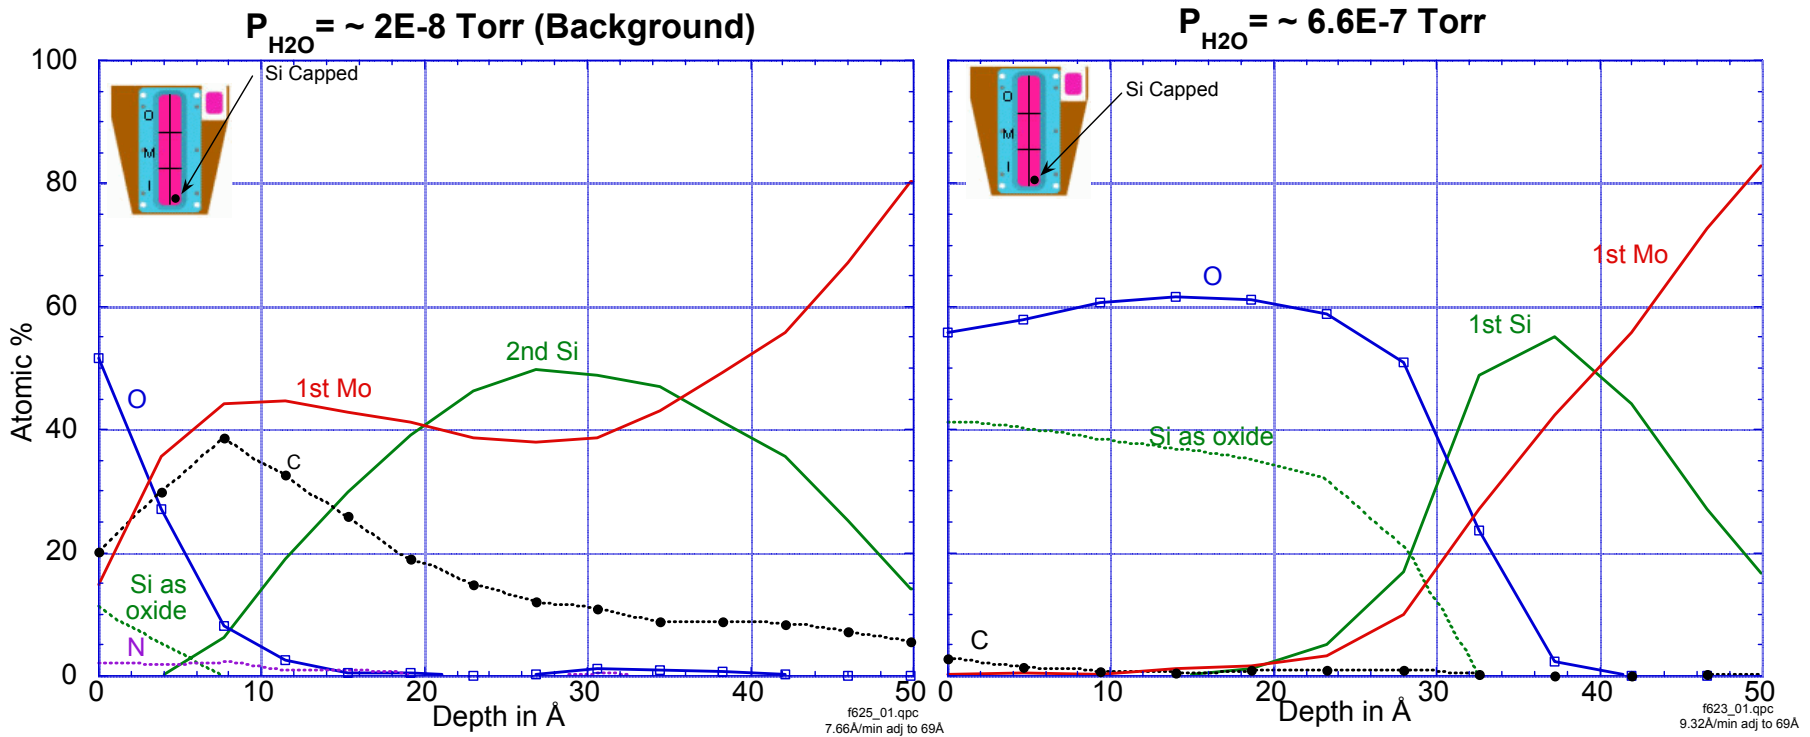
Background H₂O the source of condenser oxidation

- More C1 oxidation observed at higher P_{H_2O}
 - Note decrease in erosion rate at higher P_{H_2O}
 - Large change in with only 1 part in 10^4 change in partial pressure

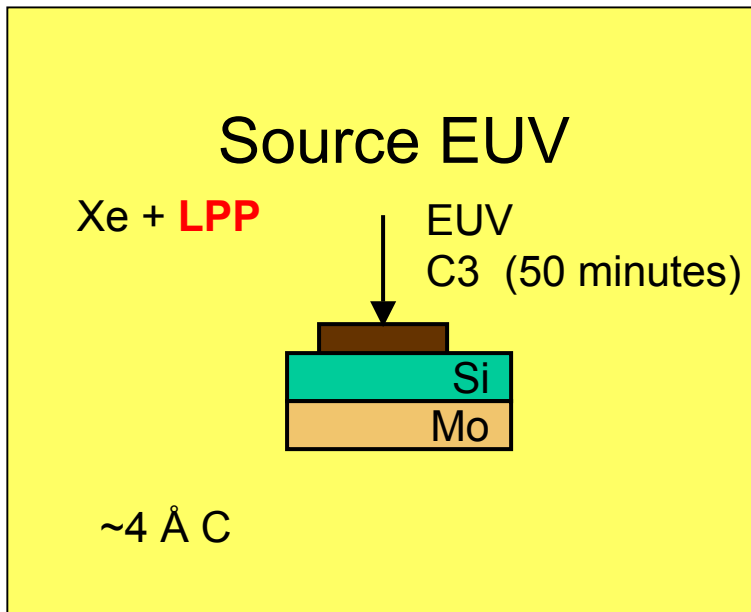
C deposition found at C3; e-beam tests showed deposition plasma related

With plasma, environment becomes carbonizing instead of oxidizing

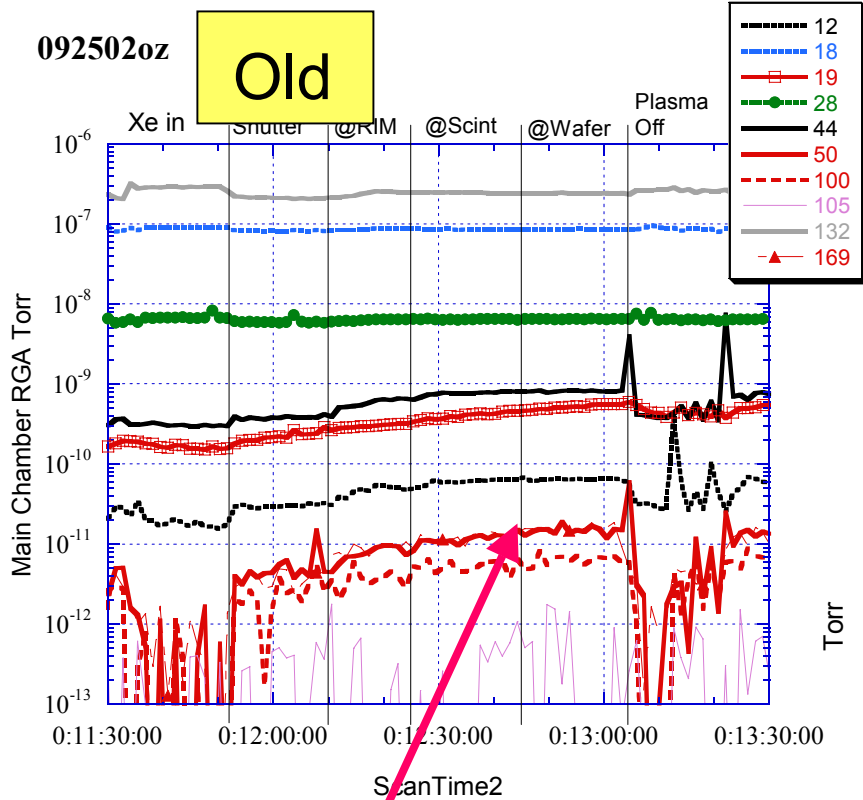
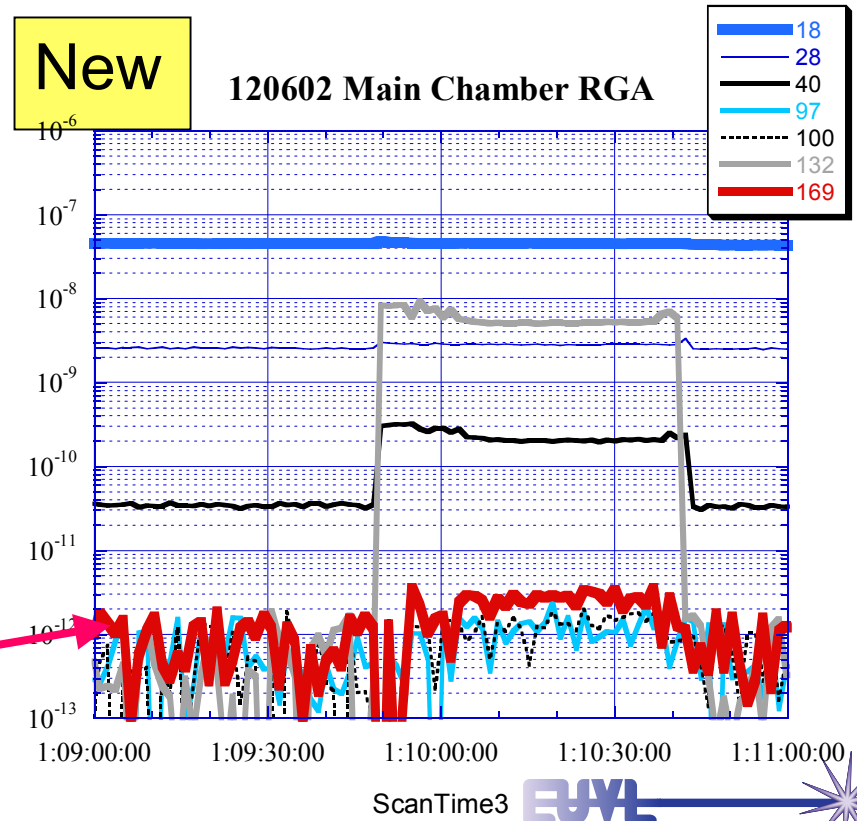
FC levels in main chamber with new seal reduced compared to old SPF seal

• Mass 169 (FC) reduced 7x

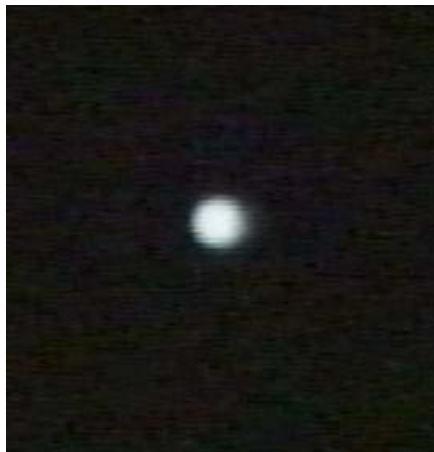
Lamp in
simmer mode

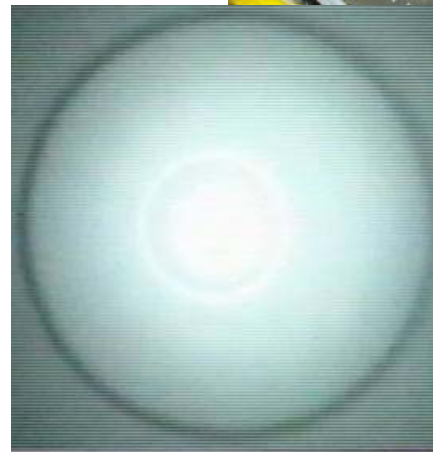
Lamp at 1 kHz

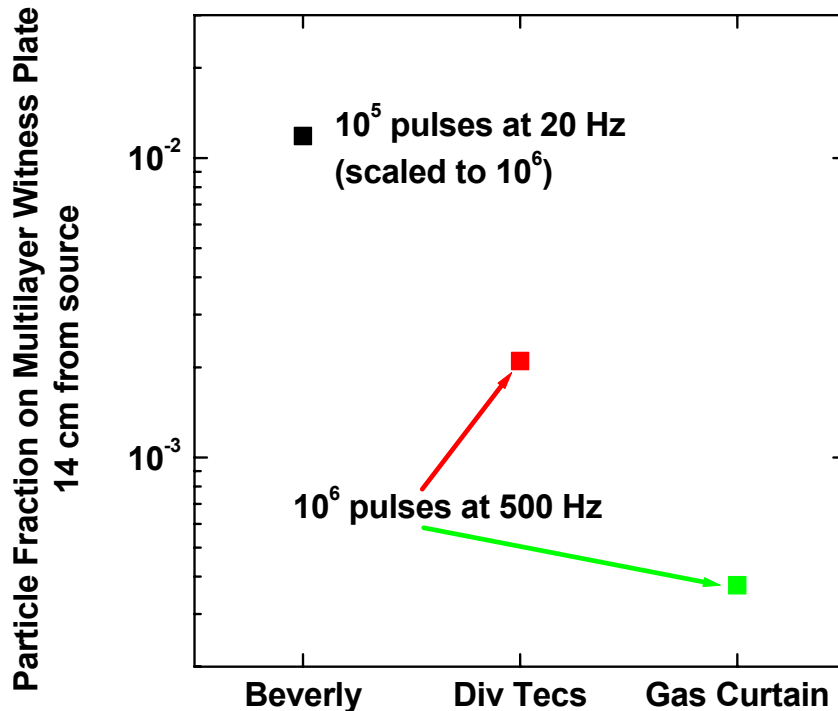
New pulser and gas curtain combined to reduced particulate deposits by 32x ...

... and no detectable atomic debris with gas curtain operating

Debris deposition rates without GC and with He background equivalent
