EUV Mask Chucking Study

- Defect Mitigation and Dynamic Flatness -

Intel Corporation

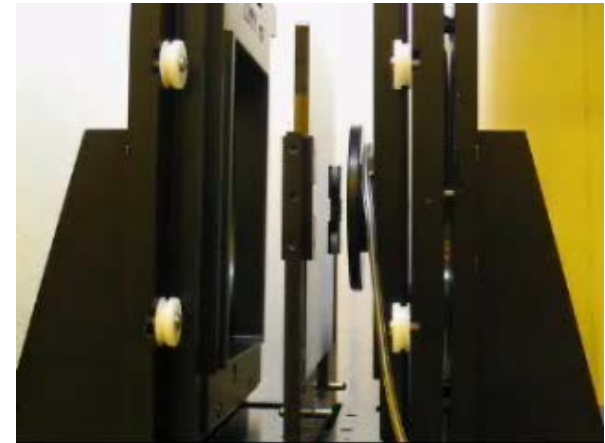
Figure 2

- Simulate chucking conditions using pressure testing apparatus.
- Chucking pressure range is between 60kPa and 300kPa.
 - Due to the sample size and minimum force which can be achieved in this apparatus, minimum pressure was larger than SEMI standard.

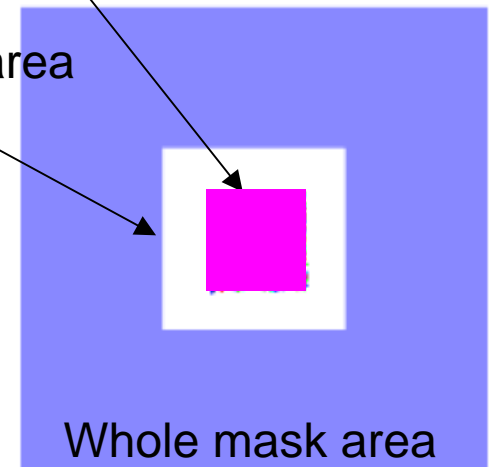
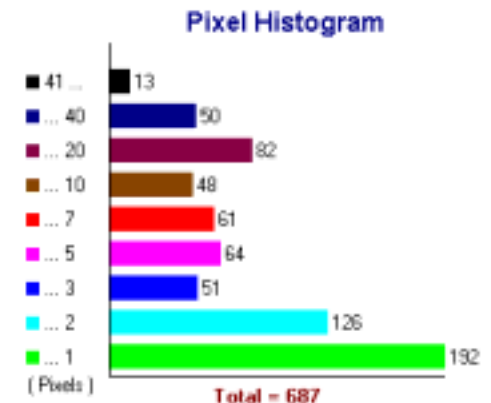
Figure 3

- Tool: Confocal laser inspection system
- Sensitivity was tuned to detect defects which sizes are larger than $1\mu\text{m}$.

Contact region with ESC material

Defect inspection area

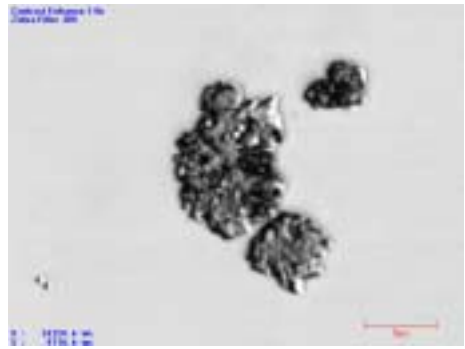
| | | Estimated Cause |
|---|---|--|
| Aggregated Defect | A scanning electron micrograph showing a large, dark, irregularly shaped aggregated defect on a light gray surface. The defect consists of several interconnected, rounded features. A red scale bar is visible in the bottom right corner. | |

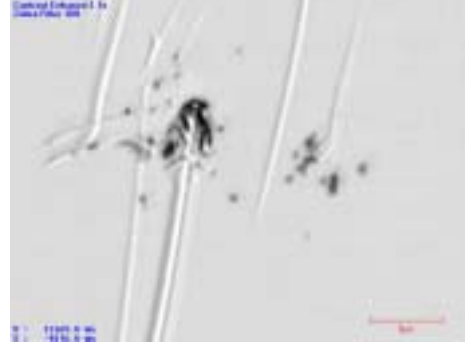
| | | Estimated Cause |
|---|---|--|
| Scratch | A scanning electron micrograph showing a dark, irregularly shaped defect on a light gray surface. The defect is surrounded by several long, thin, parallel lines that appear to be scratches or fibers. A red scale bar is visible in the bottom right corner. | <ul style="list-style-type: none">■ Rubbing motion during chucking operation. |

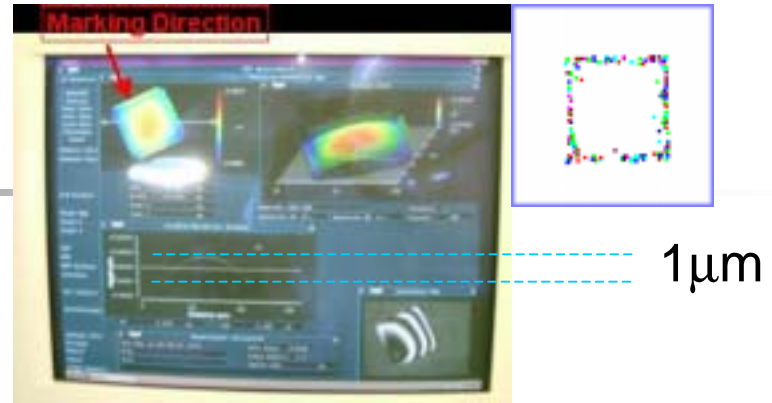
1 µm

ESC material: Sapphire
Mask backside: Cr
ESC Pre-clean: New method

Defect non-uniformity cannot be explained only by material flatness. Other factors must be considered.

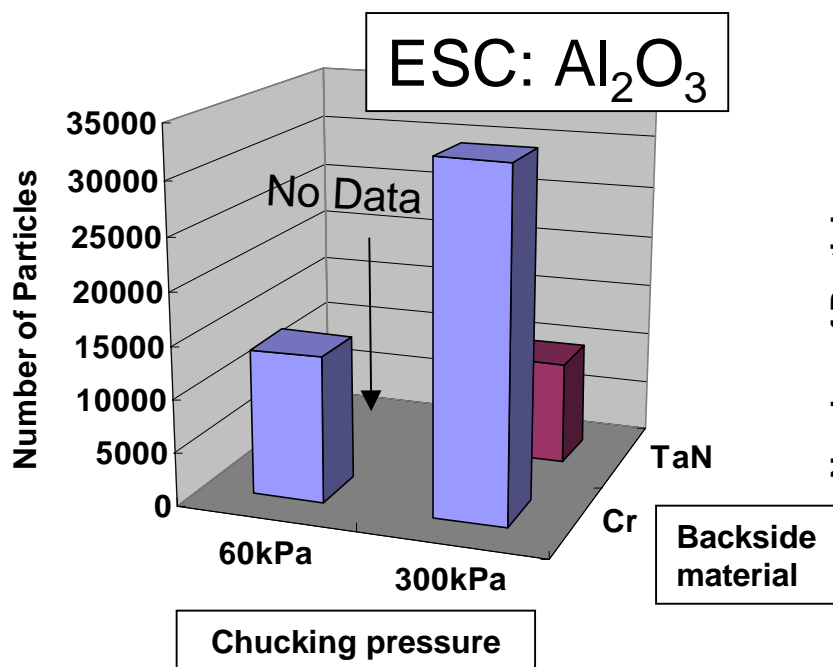
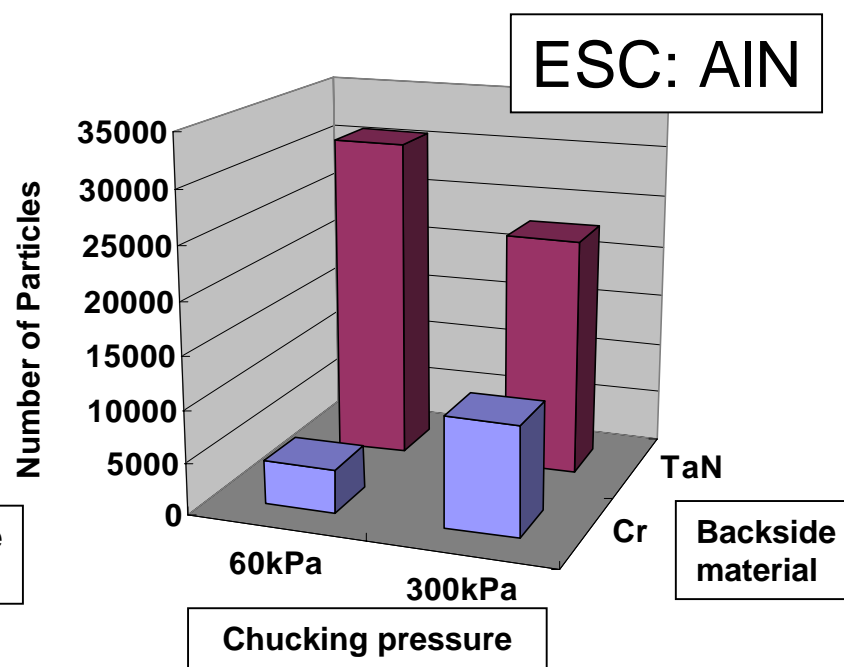
ESC material, Mask backside material and Chucking Pressure

Further evaluation will be needed to correlate experimental conditions to defect generation.

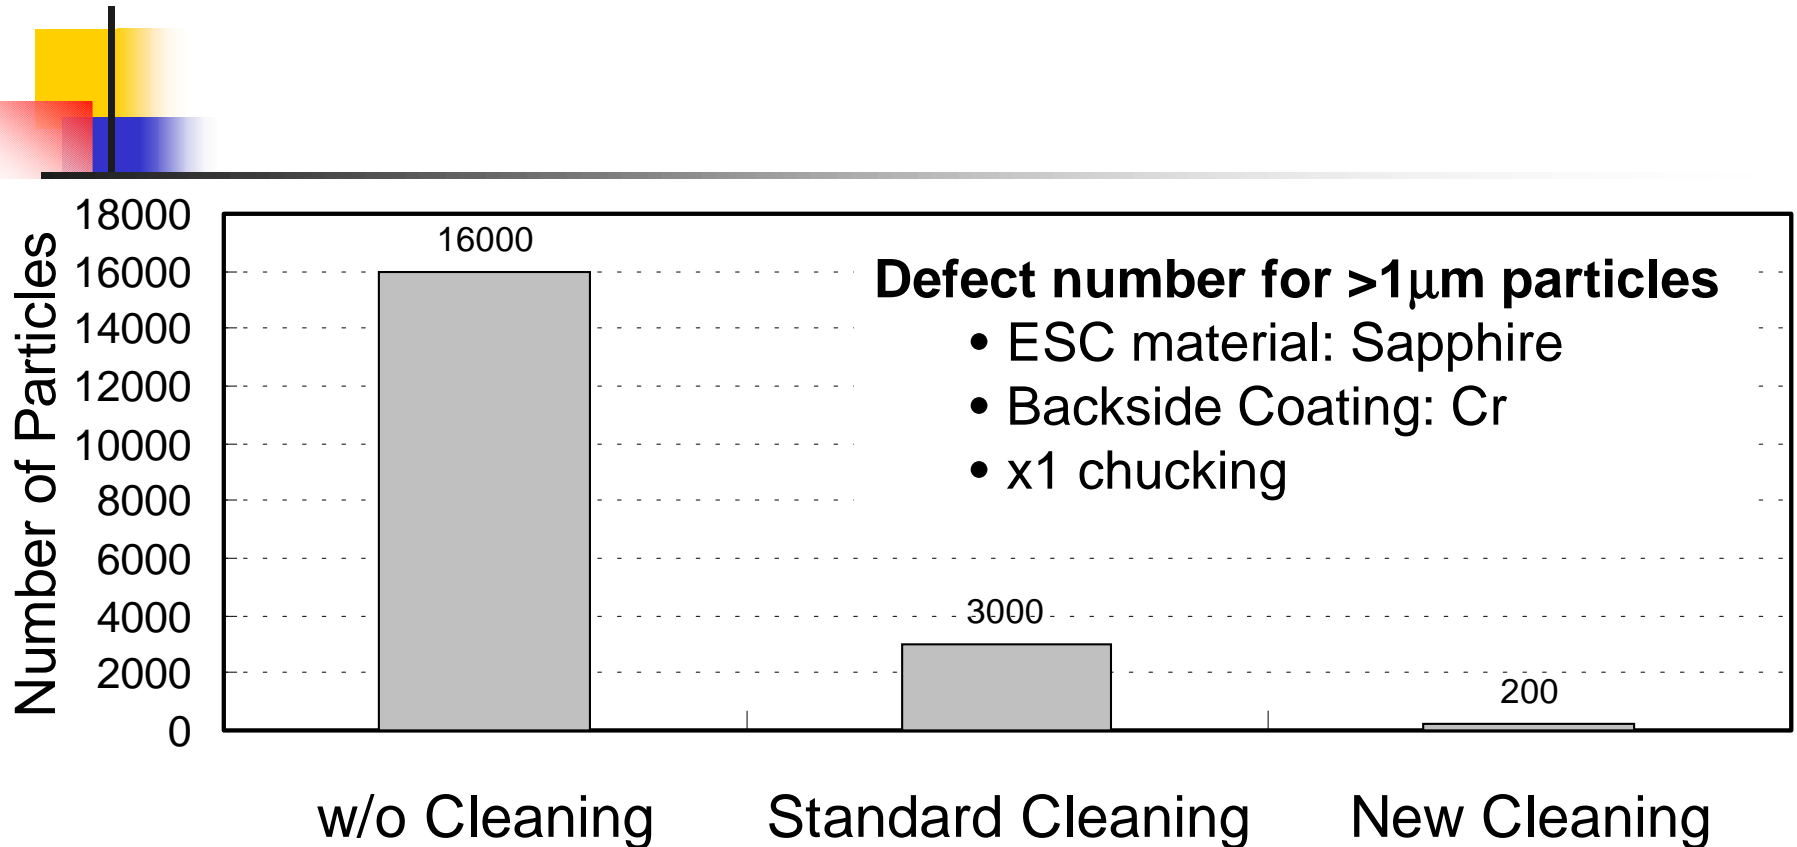
Sticky film cleaning after ultrasonic cleaning successfully mitigated defect generation with >1µm size.
