The repair performance comparison for EUV mask

Photomask Team
Semiconductor R & D Center
Samsung Electronics Co. Ltd

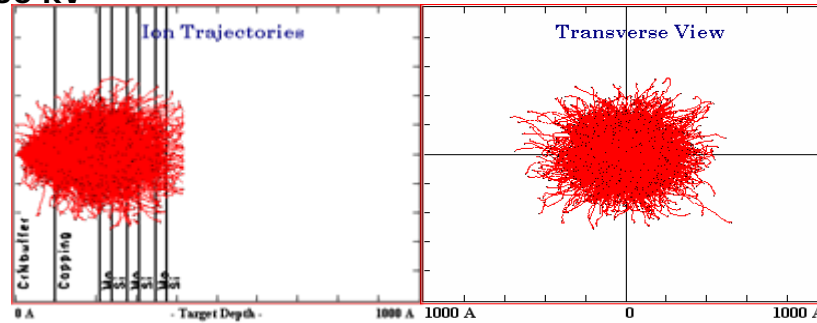
TRIM* simulation

Ion trajectory

Probability distribution

Serious multi layer damage is predicted @ 30 kV FIB.

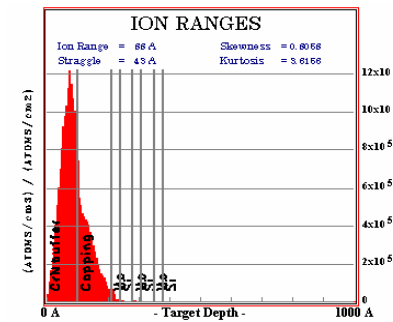
A little ion penetration to multi layer @ 10 kV ➔ Small ML damage, higher potential than 30 kV

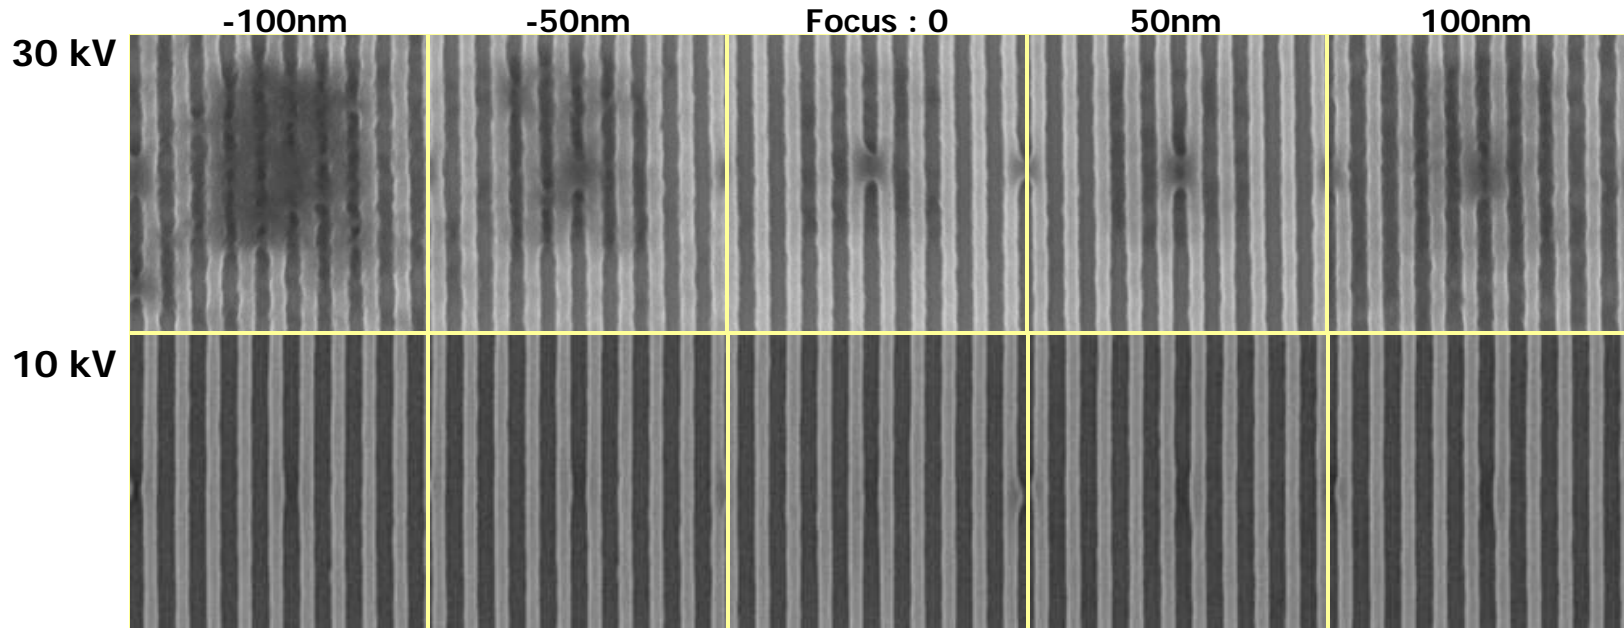
[1] 30 kV FIB vs. 10 kV FIB (60 nm) _ β gas

30 kV : Reflectance change of multi layer by ion implantation during scan → Serious edge roughness and bridge

Multi layer damage by over etching in repaired area → failure of repair

10 kV : No scan damage

Small reflectance change was observed in repaired area although multi layer damage was showed from SEM image.
