Impact of Multi-Layer Deposition Method on Hole/Scratch Type Defects on Photomask Blanks

**ASET (Association of Super-Advanced Electronics Technologies)
EUV Process Technology Research Laboratory**

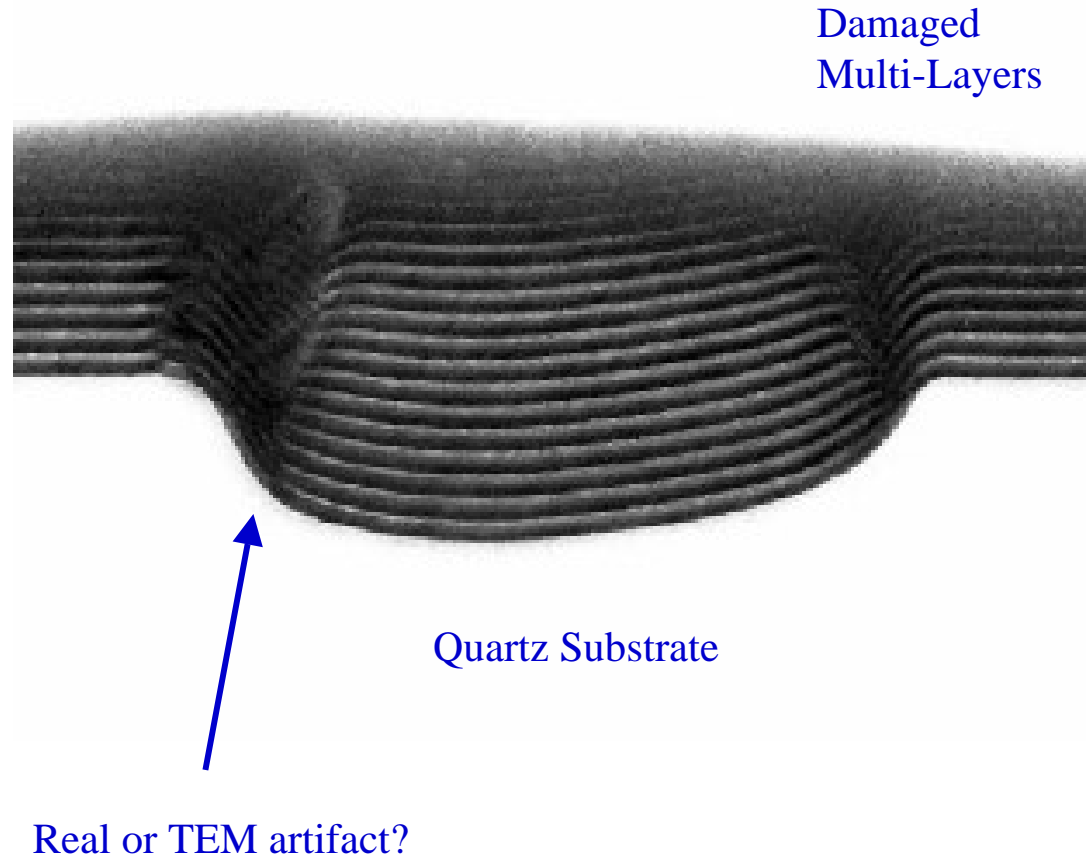
60nm ASET Mo/Si Magnetron Sputtering

60nm Scratch Defect

Limited value due to multi-layer damage during TEM sampling. Of interest is whether there is “shading” on the sides since the ASET magnetron process is not at 90° but has a slight angle to it or whether this is a TEM artifact.
